## Summary of USA Site Qualification Modules Assembled

### 1. Overview of Qualification Modules

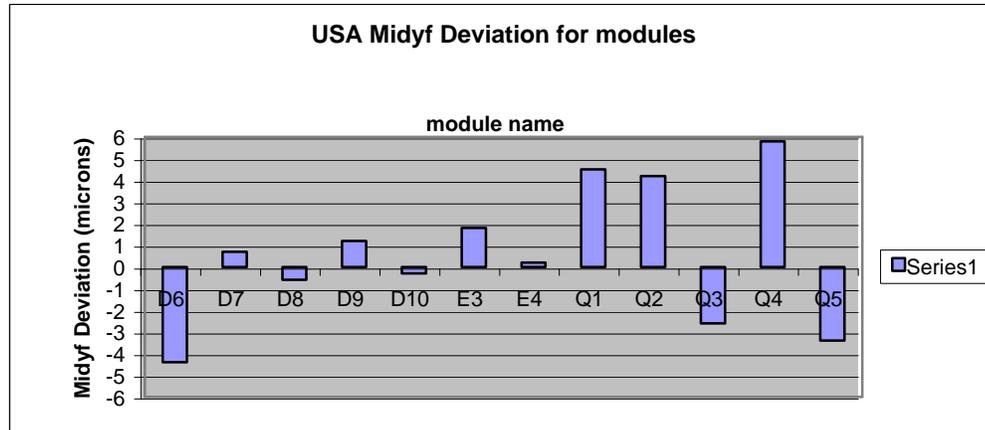
1. Midyf deviates from nominal by 5.8 microns when measured after thermal cycle. The specification is 5 microns. We have re-measured the Midfy deviation a few times over the course of assembly and it ranges between 5.1 and 5.8 microns. The value of Midyf on the other electrical and dummy modules is distributed as shown in the plot below. We don't consider the measurement process to be accurate at the sub-micron level and therefore propose that Q4 passes qualification in this parameter.

With regard to this plot, we note that modules D6-D10 used baseboards with epoxy hole washers, E3 and E4 used baseboards with old style Aluminum washers and Q1-5 used baseboards with new production style Aluminum washers.

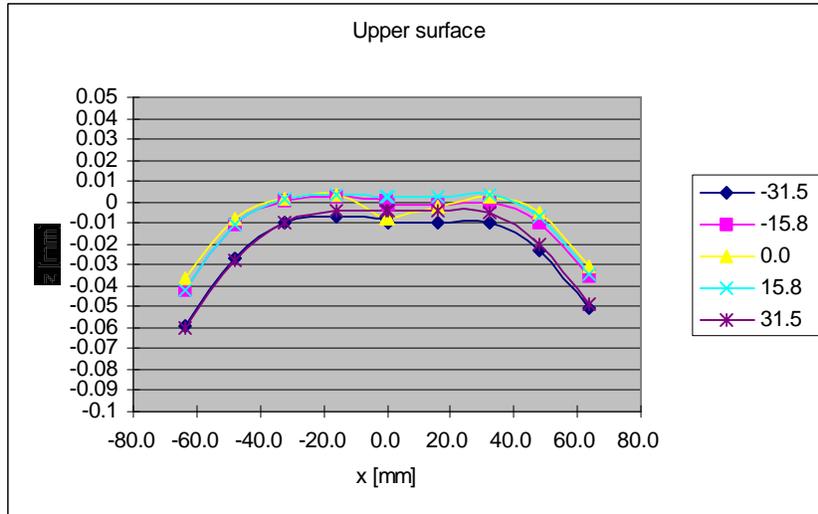
3. maxZErrorUpper and Lower: Throughout the qualification process we have been comparing to a common profile as stored in the Z metrology spreadsheets provided on the web. While the labeling of the common profile is ambiguous, as best we can determine, it corresponds to modules made with 100 type silicon. The silicon we used in the qualification series is also 100. However, it is clear that many of the modules we built are considerably flatter than those used to form the common profile. We also compared to the explicitly labeled 100 profile on the web and we remain flatter than that as well. See the figures below for an example. At worst we claim to be comparing to the wrong profile but as our modules are quite flat they should not fail qualification in this deviation. We suggest the maxZErrorUpper and Lower cuts should not be based simply upon the deviation from the common profile. They should instead be based on the requirement that the module bows by no more than 50 microns **beyond** the common profile.

Above: The official 100 profile for the upper surface from the barrel module web page.

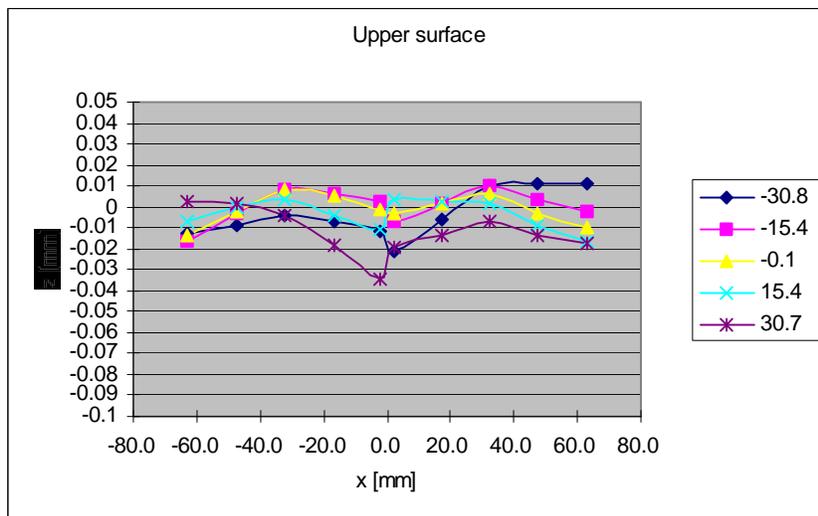
Above: Measured upper surface for USA module Q4

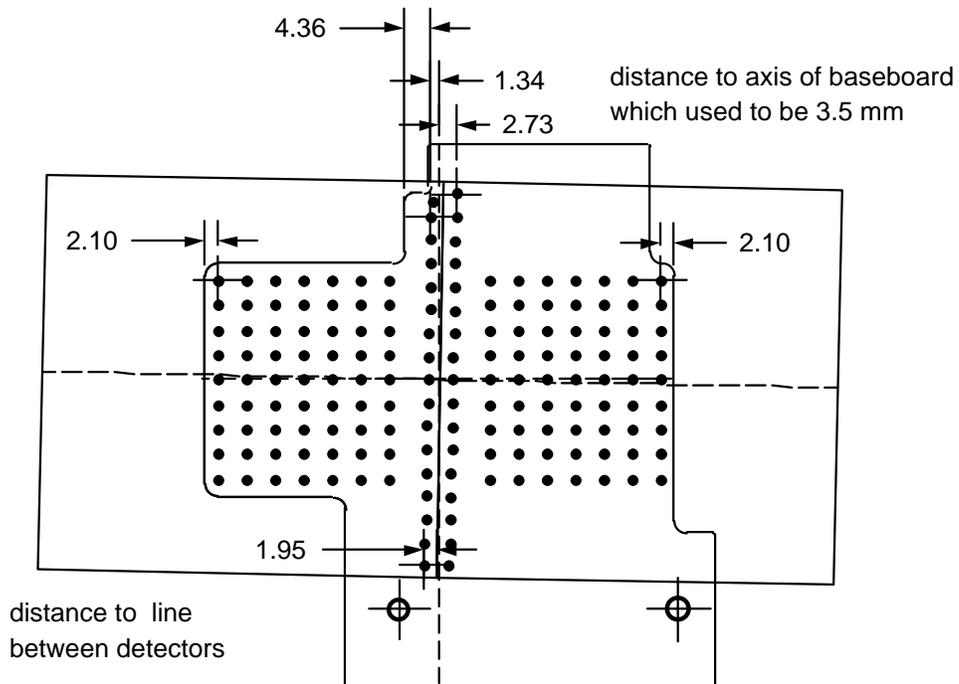
revised glue pattern to improve wirebonding performance

- In the difficult region, the bond pads are quite far from the nearest Araldite/BN glue dots. The silicon is therefore cantilevered and is seen to deflect significantly under the bonding tool. No simple variation of bonding parameters improves the bonding.
- The bonding machine force, set by a mechanical adjustment and force gauge measurement, is at the manufacturer's default value. By lowering this, and making other adjustments on controllable bonding parameters, the difficulties in this region might be reduced.

In parallel with our qualification work we made extensive studies of effect of glue dot position also using dummy parts. We plan to also study the effect of reduced bond force. With a modified glue pattern shown below, we observed a significant and dramatic improvement in bonding reliability in the difficult region. Following our study of reduced bond force we will consider requesting of the barrel module community permission to modify the glue pattern as shown. We can foresee no effect on thermal or mechanical performance from such a modified pattern.

7x9 dot regions are not changed.

2x15 dots along centerline are changed as follows:

- 1) group becomes 2x17
- 2) group is rotated by stereo angle
- 3) group is shifted closer to detector to detector gap in order to be located beneath bond pads. Distance to gap becomes 1.95 mm.
